Shining Examples of Cost-Effective Energy and Carbon Emissions Optimization in Building Renovation (Annex 56)

Energy in Buildings and Communities Programme

March 2017

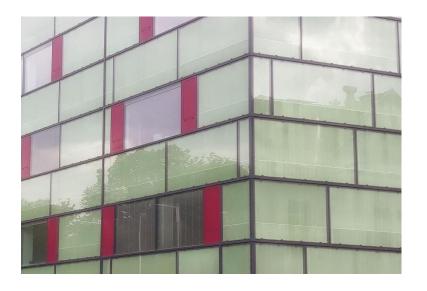
New façade system in the renovated building (© AEE INTEC)

Originally it was planned to renovate the pilot project with prefabricated timber elements with solar comb for passive solar gains. But due to the demands in fire protection no timber façade was possible. Therefore new metal façade elements with integrated solar comb had to be developed. This development required a close cooperation of all involved which increased the planning effort and also the costs of the renovation.

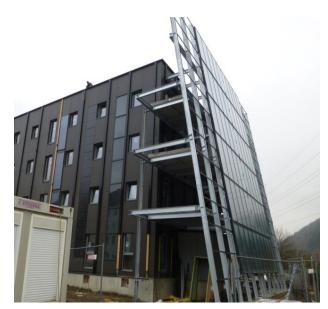
Solar thermal and PV panels on the south facade

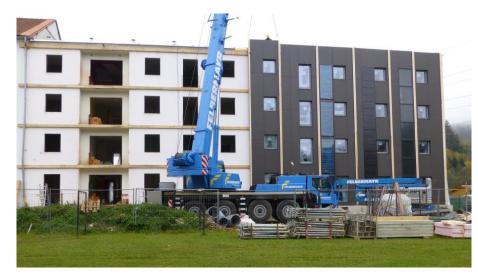
Assembling of the prefabricated façade modules on the west facade

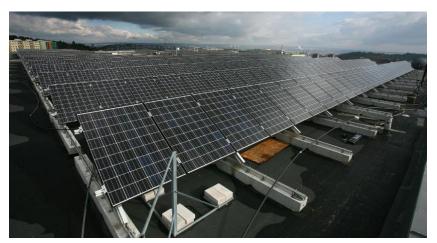
Photovoltaic panels installed on the roof of the A block. [2]

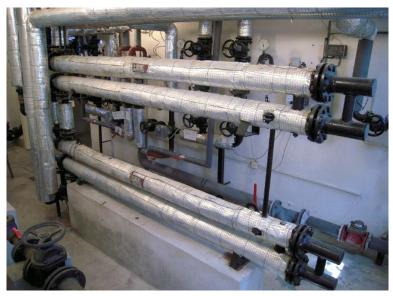
Original heat exchangers in the boiler room (before renovation). [2]

Energy for heating and DHW is supplied by two horizontal counter-flow heat exchangers in a boiler room on the ground floor of the building. The heating system has two main sections (East and West) representing east- and west-oriented flats. Both sections have equithermal regulation. There are gilled radiators installed in the whole building. All the radiators have thermostatic heads (since 2002). During the renovation the measuring and regulation equipment was replaced. Electronic sensors of exterior temperature were installed. Old circulation pumps were replaced by new ones with electronic regulation. Old damaged valves and heads were replaced.

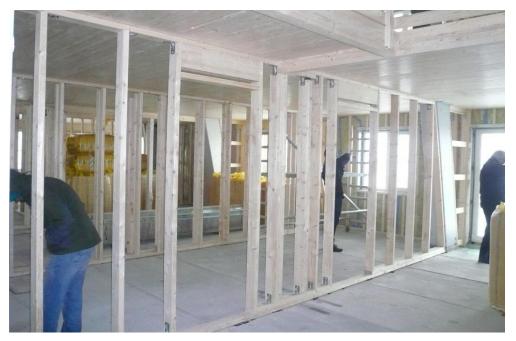
New internal walls and inserted deck at the first floor of block B.

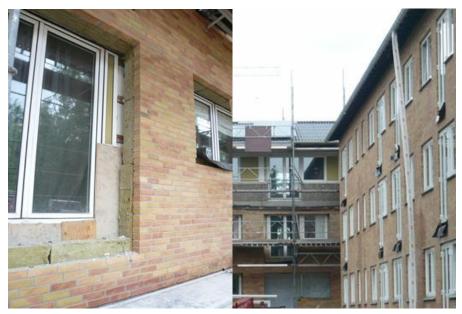
190 mm insulation plus exterior solid standard bricks. Energy windows – aluminium – wood, 3-layer energy glass. In the panel walls: 285 mm insulation plus exterior solid standard bricks.

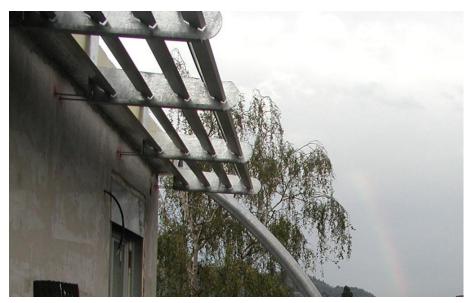
New shading devices.

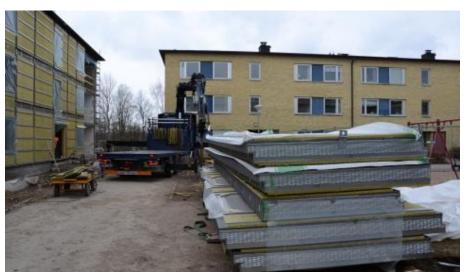
Prefabricated facade elements for the next phase of renovation.
